GAO

July 1997

AFLOAT PREPOSITIONING

Not All Equipment Meets the Army's Readiness Goal

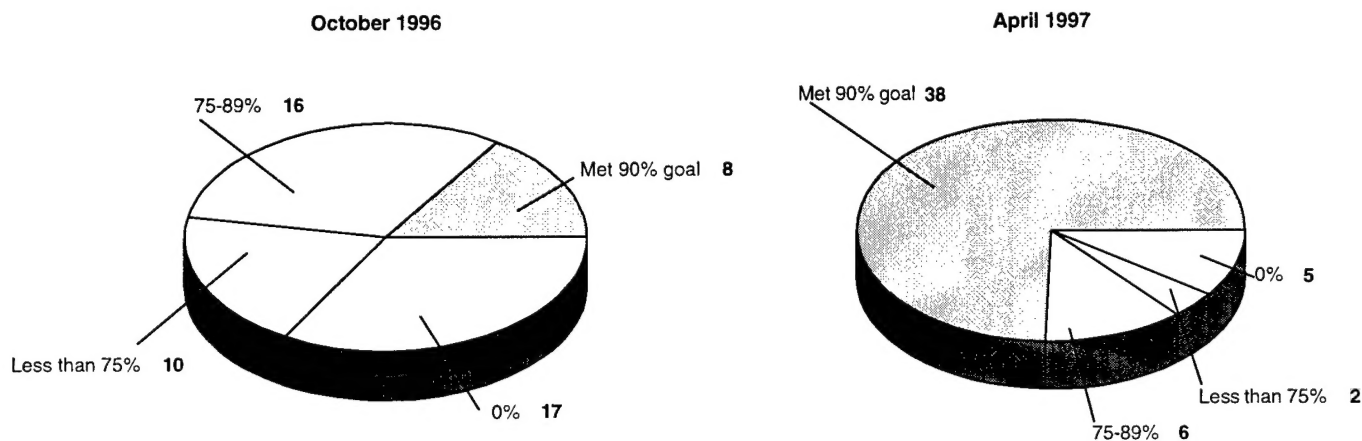
Figure 1: Number of Equipment Sets That Did Not Meet the Army's Readiness Goal in October 1996 and April 1997

As of April 1997, 13 of the 51 unit sets of equipment that are assigned to Army prepositioning ships and considered for readiness reporting, or about 25 percent, did not meet the Army's readiness goal that 90 percent of available war reserve equipment be fully mission capable. Equipment in two unit sets was less than 75 percent fully mission capable, and five unit sets had a fully mission capable rating of zero because they did not have on hand any authorized primary weapon systems or equipment considered critical for accomplishing and sustaining a unit's mission. For example, one unit set designated to support a heavy equipment transport company did not have any of its authorized trucks or trailers.

The status of the equipment in April 1997 had significantly changed from October 1996, when 43 of the 51 unit sets did not meet the Army's goal. At that time, equipment in 10 unit sets was less than 75 percent fully mission capable, and 17 unit sets had a fully mission capable rating of zero because they did not have any of their authorized reportable equipment on hand.

Army officials attributed the improvement as of April 1997 primarily to the transfer of key pieces of equipment considered for readiness reporting from lower priority units not considered for readiness reporting to higher priority units that are considered for readiness reporting.⁵ The officials said that maintenance on the equipment between October 1996 and April 1997 also contributed to the increase in the number of unit sets that met the Army's readiness goal. Figure 1 compares the status of equipment sets in October 1996 and April 1997.

Note: The unit sets that had a fully mission capable rating of zero did not have any reportable equipment on hand.

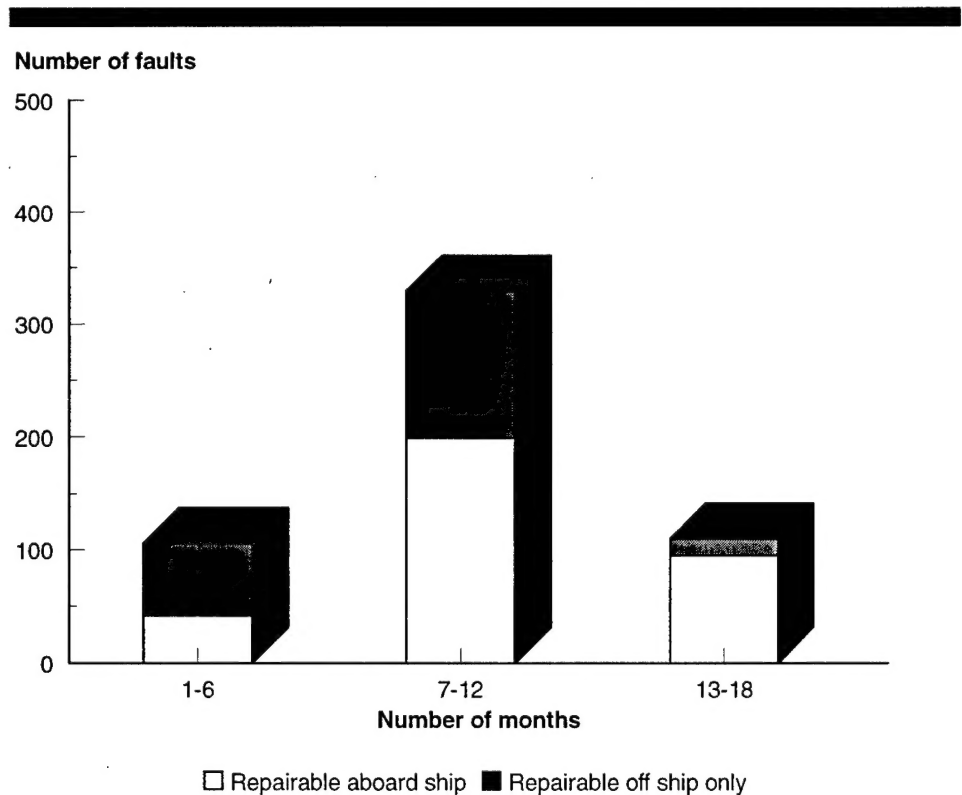
Figure 2: Amount of Time That Uncorrected Faults Have Rendered Equipment Non-Mission Capable (as of Apr. 1997)

The Army's equipment status data, as of April 1997, showed that faults rendering specific pieces of equipment non-mission capable had remained uncorrected since September 1995. Figure 2 shows the amount of time that uncorrected faults have rendered equipment prepositioned afloat non-mission capable and the portion of those faults that the Army considered to be repairable while in storage aboard prepositioning ships.

Note: Data reflects all ships as of April 1997 with the exception of one for which data was only available as of January 1997.

To improve the quality of Army equipment status reporting, we recommend that the War Reserve Support Command, along with intended users of the Warfighter Equipment Status Reports, establish more accurate designations for the status of non-mission capable equipment. These designations should differentiate among items that can be repaired aboard ship, items that are to be repaired by the logistics support team upon download before deployment, and items that may not be readily repaired and should be replaced.

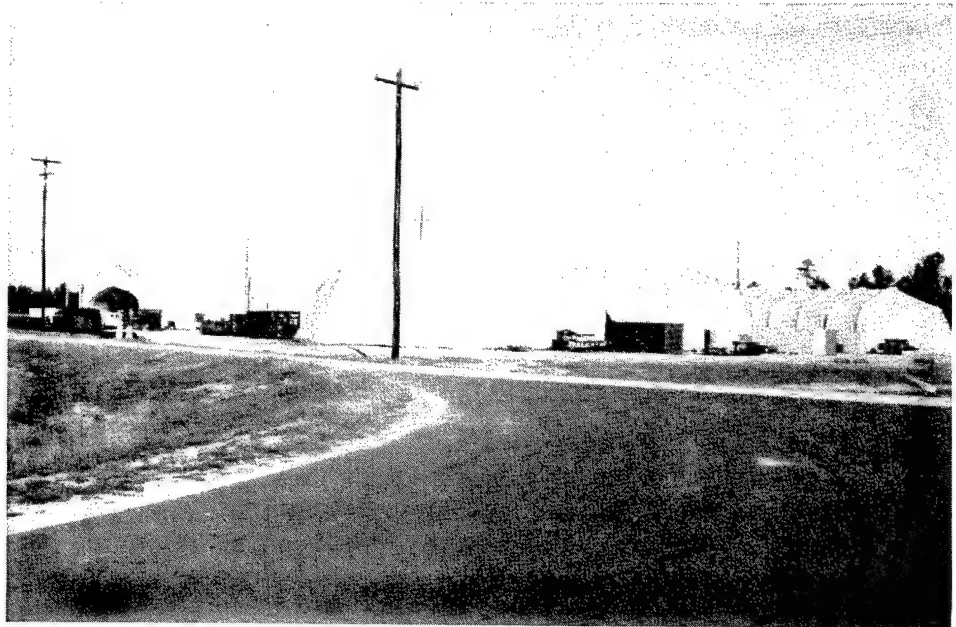
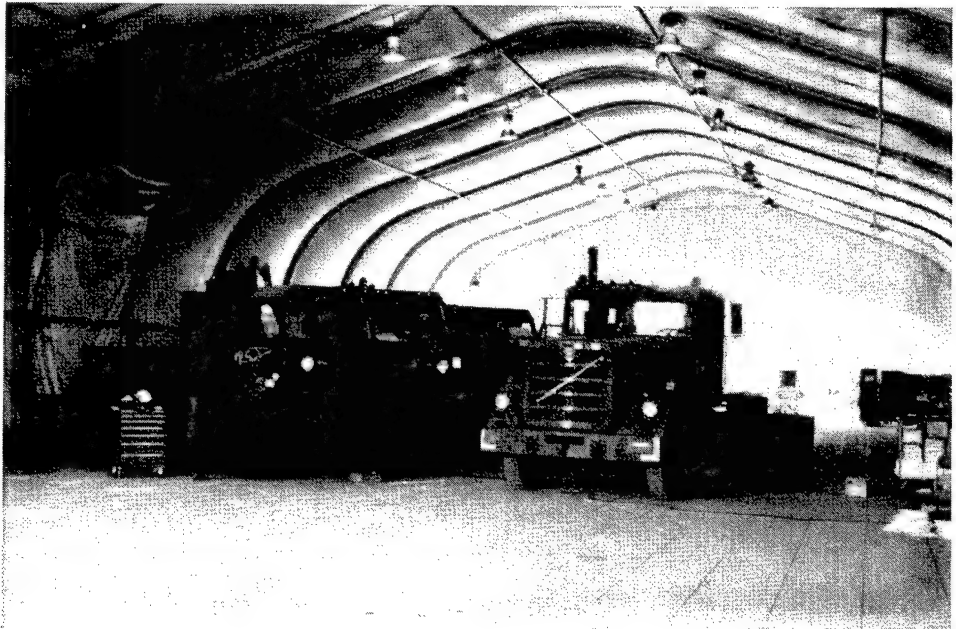
Figure 3: Temporary Maintenance Shelters at the Charleston, South Carolina, Site

The Army received a total of \$45.7 million in fiscal year 1995 and 1996 appropriations for construction of a maintenance facility at Charleston, South Carolina. The site preparation and the initial phase of construction were originally scheduled to be completed before October 1996—in time for the facilities to be used to conduct maintenance on the first full shipload of the brigade set of equipment, which is prepositioned afloat. However, contractors did not complete scheduled construction and renovation projects in time. As a result, the maintenance contractor had to continue to rely on temporary shelters instead (see fig. 3) and had to develop less efficient maintenance processes.

According to Army officials, the construction delays were primarily due to poor soil conditions and the removal of unanticipated hazardous waste, such as asbestos and pigeon droppings, from existing structures.⁹ The officials said that the continued reliance on temporary maintenance facilities did not delay the successful upload of fully mission capable equipment. They also said that the only discernable impact of these less efficient working conditions was a slight but unquantifiable increase in the amount of overtime charged to the contract. The Army plans to complete the transition of maintenance operations from the temporary shelters to the permanent facilities in fall 1997. In accordance with the original facility funding plan, the Army requested \$7.7 million in fiscal year 1998 for further construction at the site, making the total estimated cost for the facility \$53.4 million.
